QUEENSLAND BUILDING AND
CONSTRUCTION COMMISSION

TIMBER DECK AND BALCONY CONSTRUCTION

TIMBER DECKS AND BALCONIES

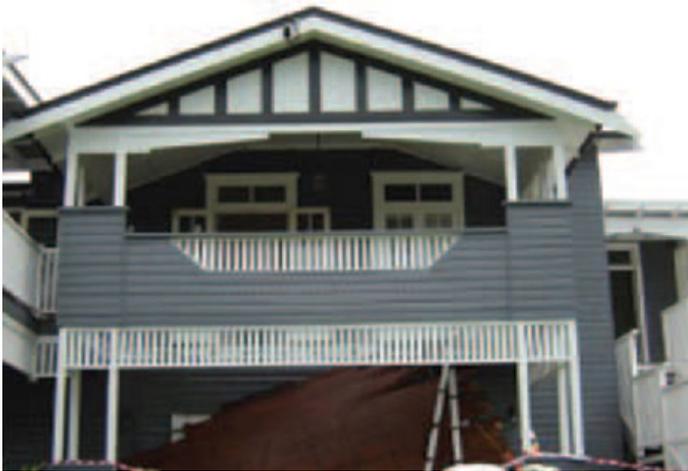
Ascot residence subject to balcony collapse

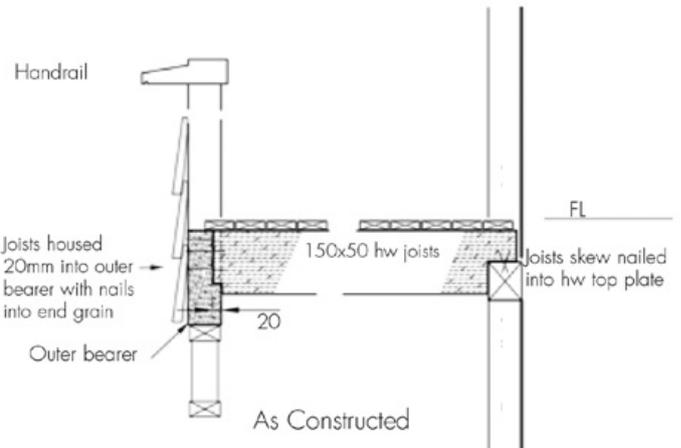
The front balcony measured approximately 6.5 metres x 2.75 metres and appeared to be part of the original dwelling. Deck joists were approximately 145 x 55 hardwood fixed at approximately 500mm centres and were cogged into a check-out housing in a deck bearer running across the front of the balcony and cogged over a floor plate where attached to the main residence. The joists were skew nailed to the bearers and many of the nails showed evidence of significant corrosion.

Cross-section of Ascot deck as constructed.
(Drawing provided with generous permission of Peter Wright RPEQ)

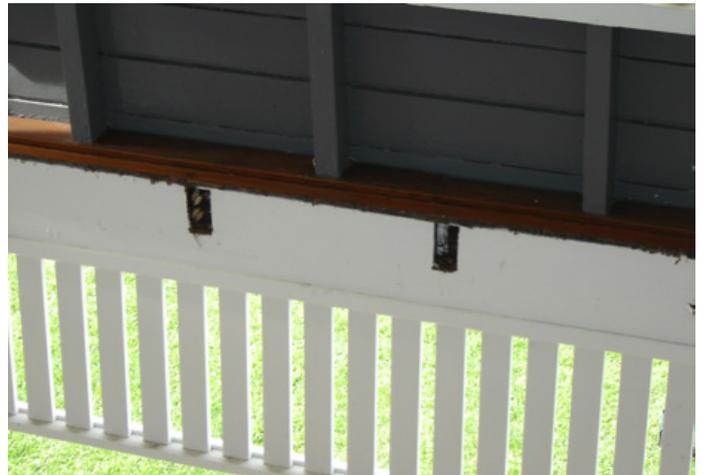
Cause of collapse - Over a long period of time the external balcony bearer deflected outward due to the inadequate restraint provided by the nail fixings into the bearers. Corrosion of the nails may have contributed to the inadequate restraint. As the bearer deflected outward the joists began to be displaced from their housing in the bearer and this is evidenced by paint on the ends of joists and into the bearer housings.

Housings in the bearer

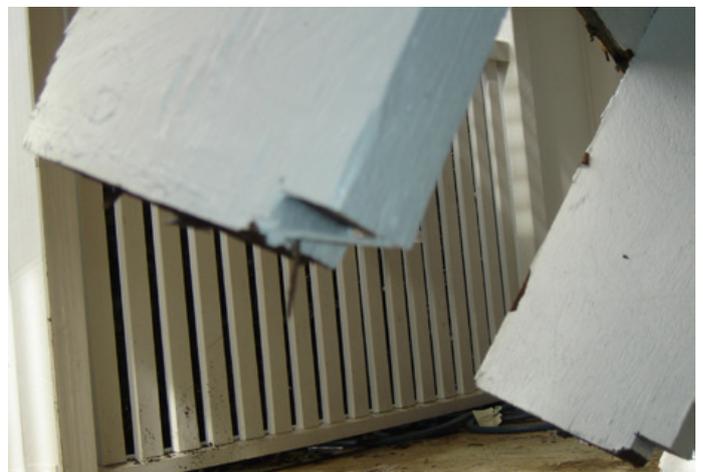
Paint clearly evident inside the cog in the joist

In fact paint witness marks indicate that on a small number of joists the full depth of cog measured to be approximately 18 to 20mm had disengaged from their housing due to an outward deflection of the main bearer.

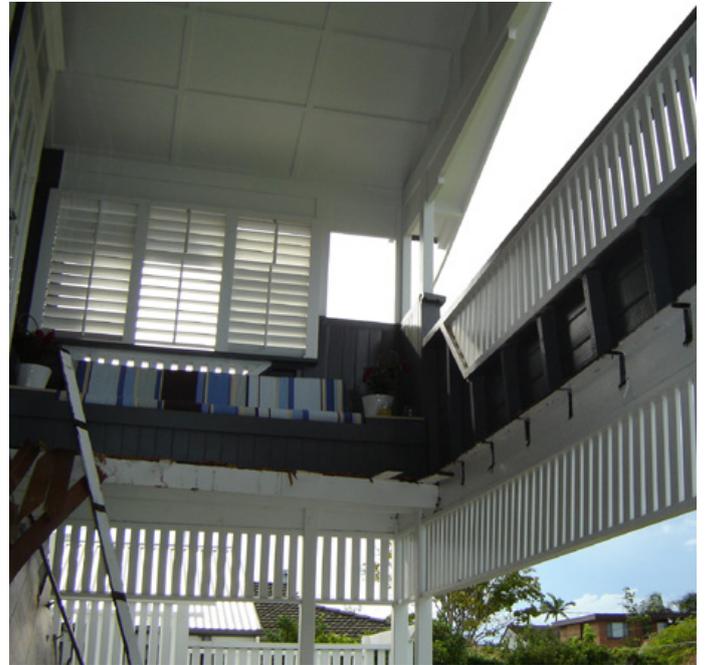
View of external bearer support

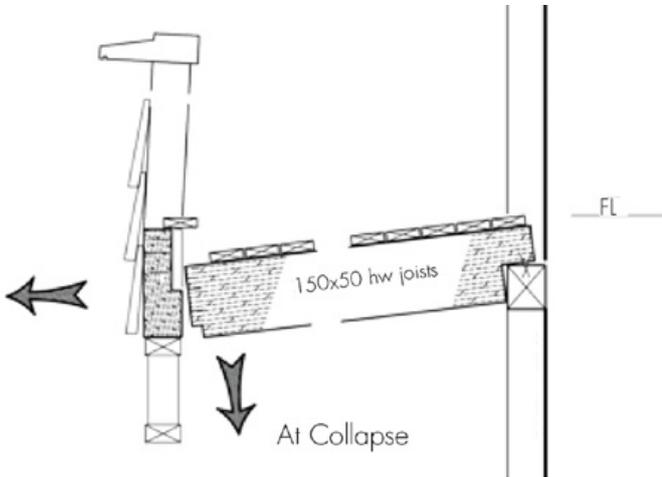
Once one or two floor joists became disengaged they started a progressive collapse of adjacent floor joists due to a probable outward thrust on the floor bearer as the joists rotated downwards, allowing adjacent joists to pull out of their housing in the bearer.

Cross-section of Ascot deck at time of collapse.
(Drawing provided with generous permission of Peter Wright RPEQ)

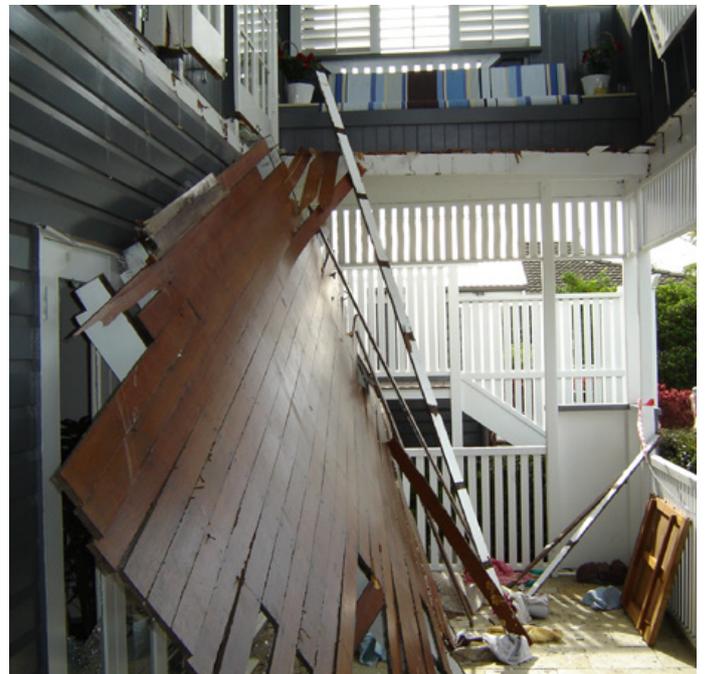
View of collapsed deck

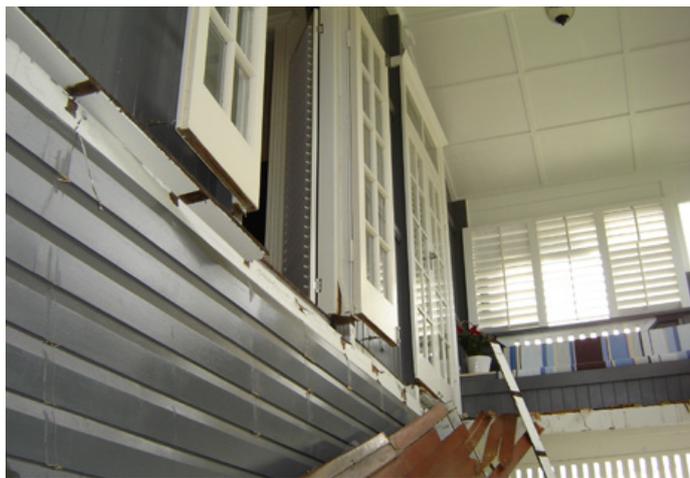
View of internal bearer support at external wall of home

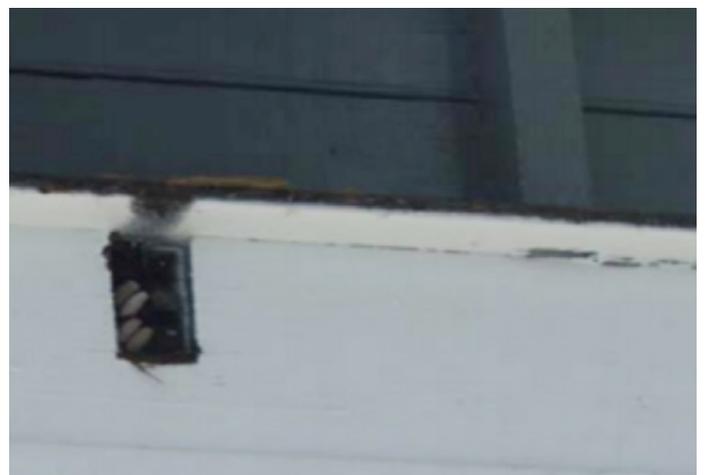
Mud wasp nests in the bearer housing is evidence that a sizeable gap existed where the floor joist cog was not fully engaged into the bearer

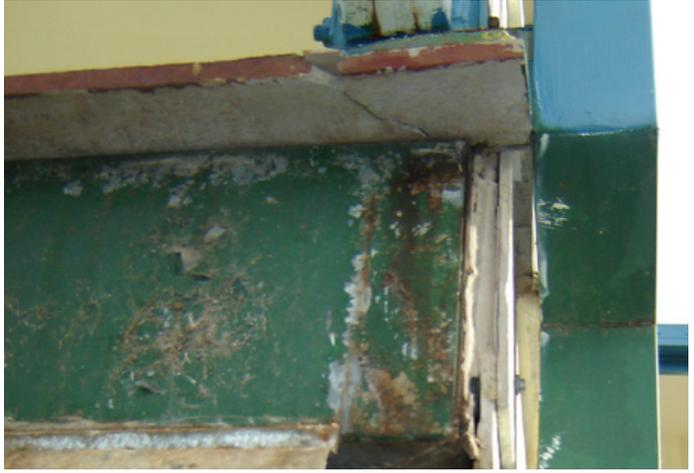
Cause of collapse - It appears that the south-west corner of the deck failed initially where the deck bearer was attached to the main dwelling. It was further found that the deck bearer that failed penetrated the external cladding boards and relied upon support by multiple pine corner wall studs in the wall cavity. The pine wall studs supporting the bearer were found to be totally rotted out due to the ingress of water into the wall frame.

Support point for the bearer

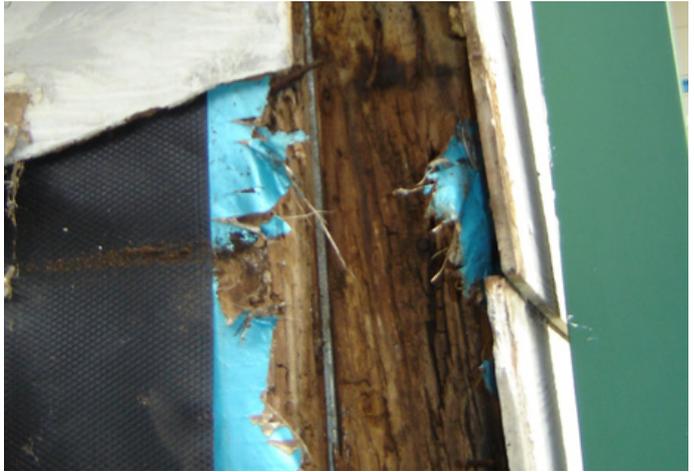
Rotted wall studs below the bearer support joint

Shrinkage/breakdown of the sealant over many years and some shrinkage of timber elements would have occurred, allowing water ingress and causing the decay to the non-durable pine studs in the enclosed wall.

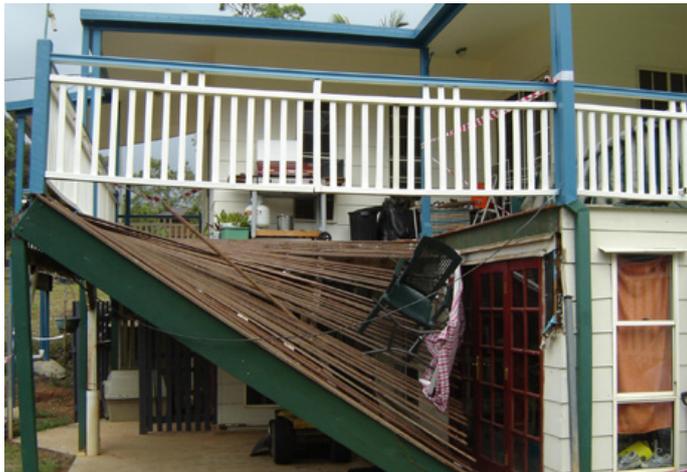
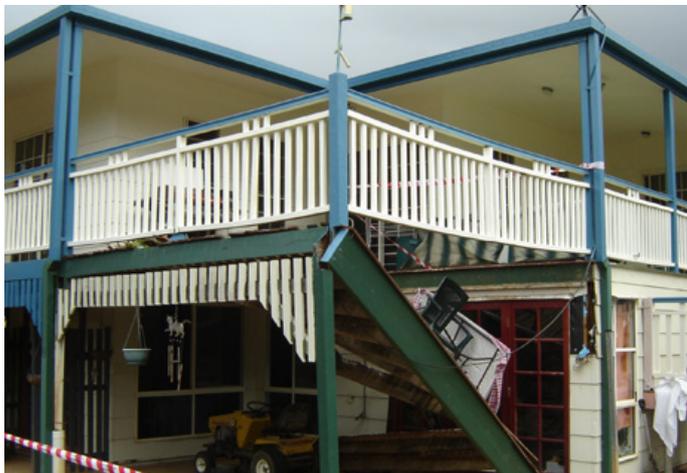
When a substantial load was applied to the deck in the direct vicinity of the south-west corner over the bearer being supported by rotted wall studs, the inadequate support allowed the bearer to rotate downwards and the collapse occurred.

Collapsed corner of the deck is clearly visible in these photographs

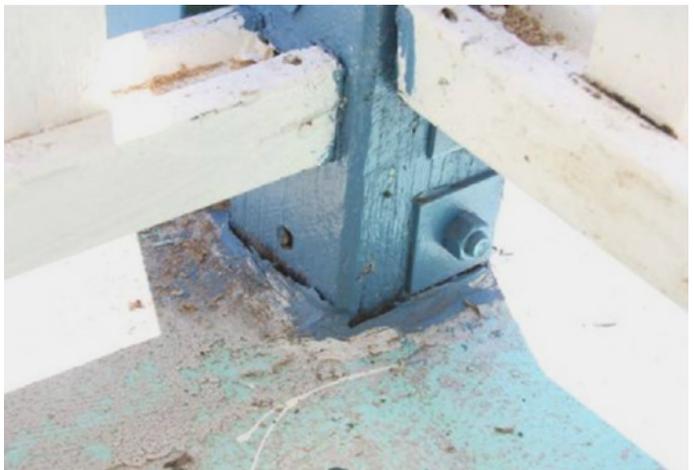
The ingress of water may have occurred where the bearer itself penetrated the wall cladding and also around the base of a timber veranda post of the main dwelling which was located directly above the location of the bearer. These points of water ingress relied solely upon sealant to prevent penetration of water.

Gaps around base of veranda post allow water ingress into wall cavity

- All structural framing members and their connections and support points below the floor level of structures such as decks, balconies and patios should be unenclosed and not sheeted to allow full visual inspection of those critical elements.
- When structural framing members and their connections and support points are enclosed and not visible for inspection, all framing and connections should be sufficiently durable to accommodate periodic wetting and drying. Alternatively, a method of inspecting the sub-structure to the deck and any building framing to which deck members are connected should be provided.
- No attachments to a dwelling such as patios, decks, balconies or the like should allow structural framing members to penetrate the external fabric of the main building unless the penetrations are flashed and sealed using permanent durable materials to prevent moisture entry.
