**THIS  
HANDY TOOL  
WILL HELP  
YOU PREVENT  
DEFECTS IN  
TIMBER DECK  
AND BALCONY  
CONSTRUCTION**

# TIMBER DECKS AND BALCONIES

## THE ASCOT COLLAPSE

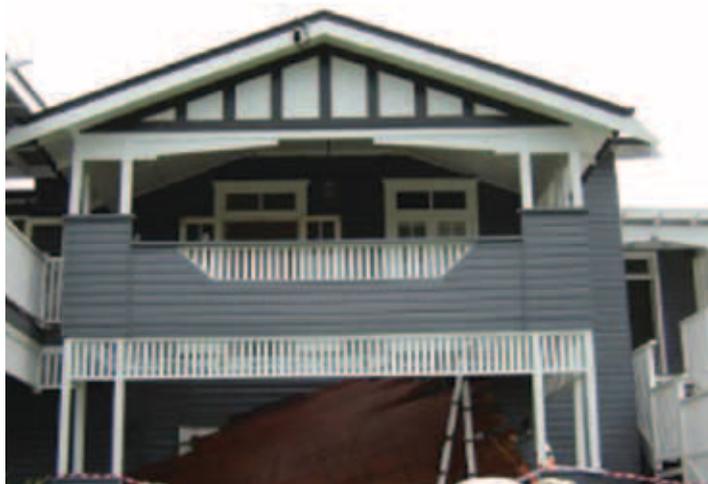
Ascot residence subject to balcony collapse

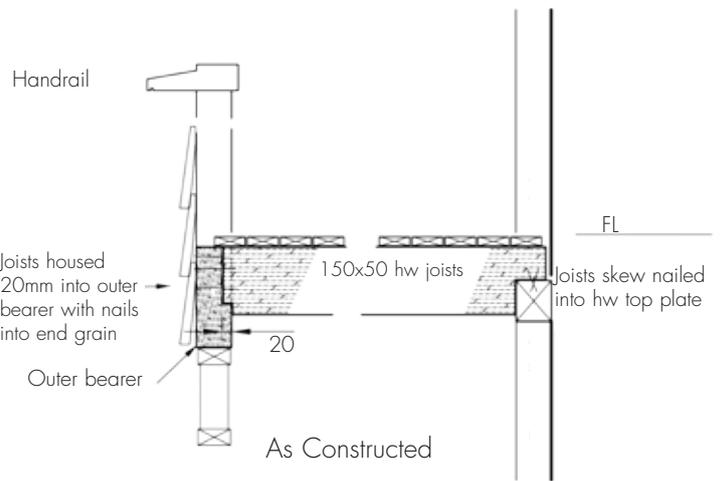
The front balcony measured approximately 6.5 metres x 2.75 metres and appeared to be part of the original dwelling. Deck joists were approximately 145 x 55 hardwood fixed at approximately 500mm centres and were cogged into a check-out housing in a deck bearer running across the front of the balcony and cogged over a floor plate where attached to the main residence. The joists were skew nailed to the bearers and many of the nails showed evidence of significant corrosion.

Cross-section of Ascot deck as constructed.

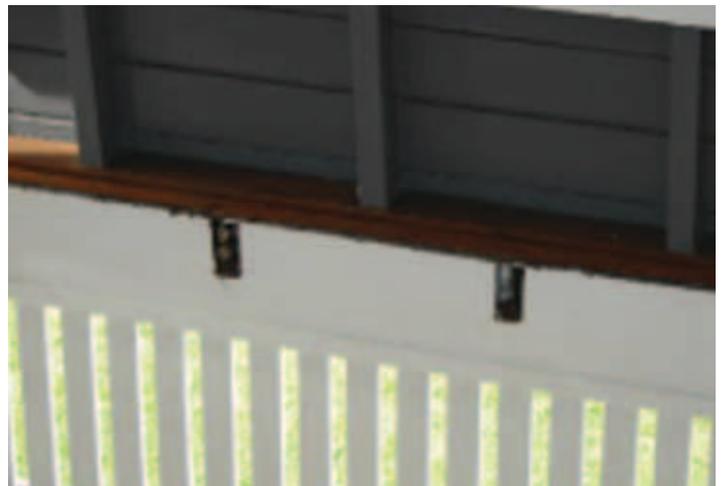
**Cause of collapse** - Over a long period of time the external balcony bearer deflected outward due to the inadequate restraint provided by the nail fixings into the bearers. Corrosion of the nails may have contributed to the inadequate restraint. As the bearer deflected outward the joists began to be displaced from their housing in the bearer and this is evidenced by paint on the ends of joists and into the bearer housings.

Housings in the bearer

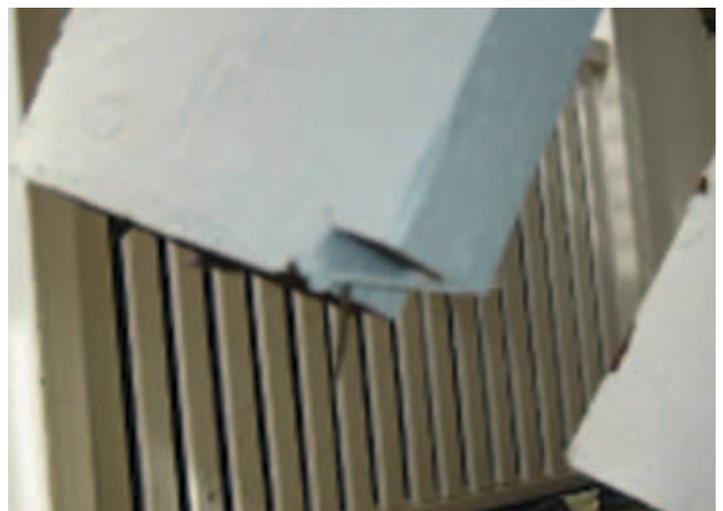
Paint clearly evident inside the cog in the joist

In fact paint witness marks indicate that on a small number of joists the full depth of cog measured to be approximately 18 to 20mm had disengaged from their housing due to an outward deflection of the main bearer.

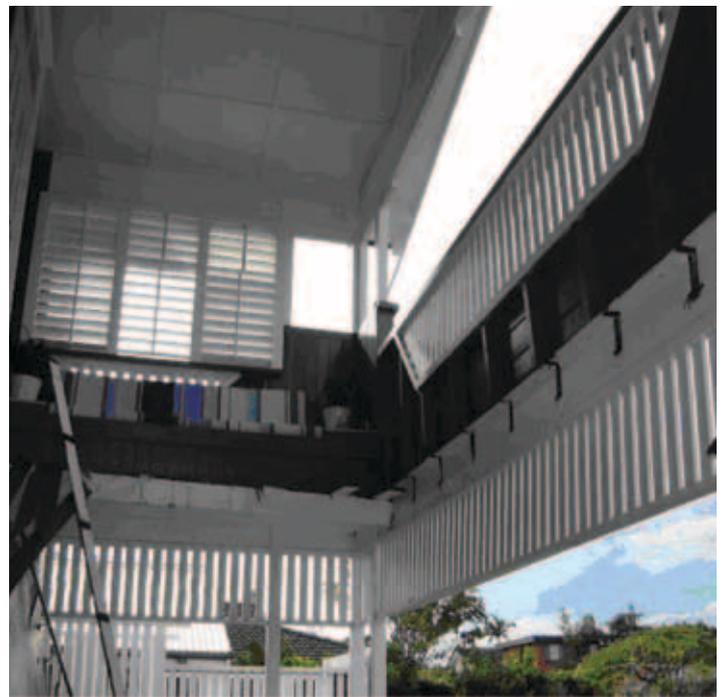
View of external bearer support

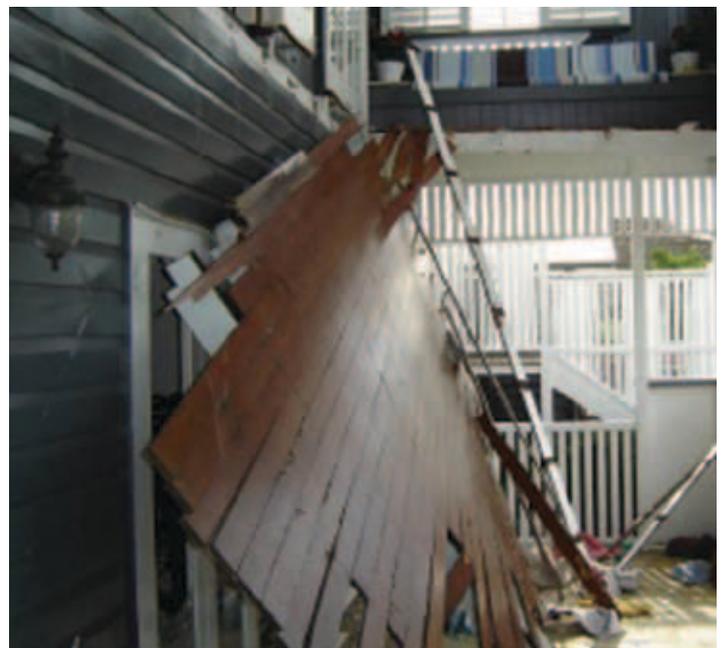
Once one or two floor joists became disengaged they started a progressive collapse of adjacent floor joists due to a probable outward thrust on the floor bearer as the joists rotated downwards, allowing adjacent joists to pull out of their housing in the bearer.

View of collapsed deck

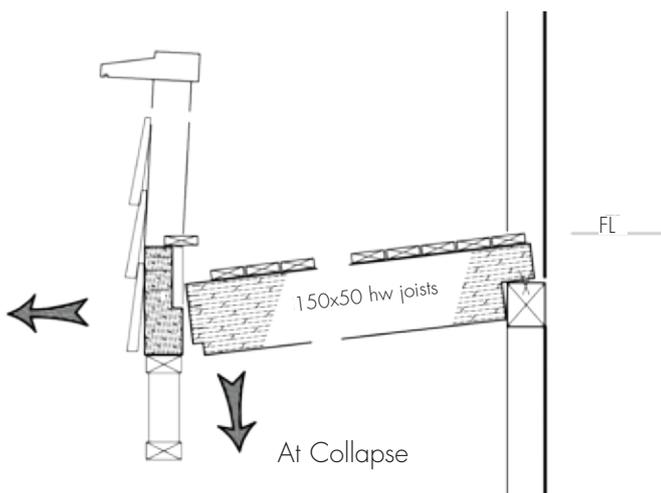
Cross-section of Ascot deck at time of collapse.

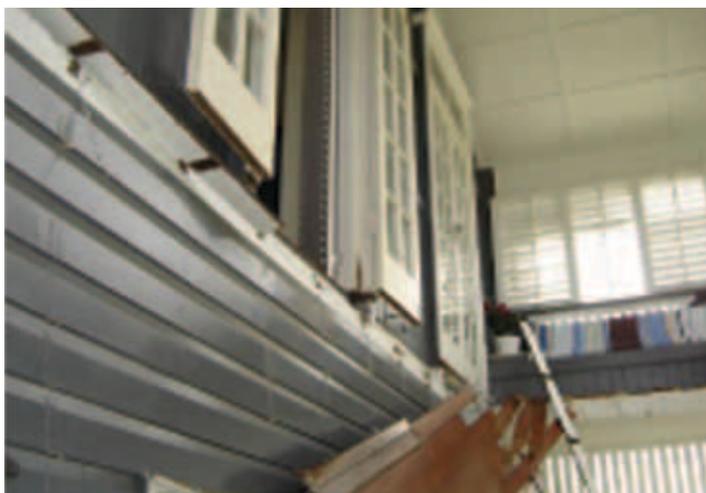
View of internal bearer support at external wall of home

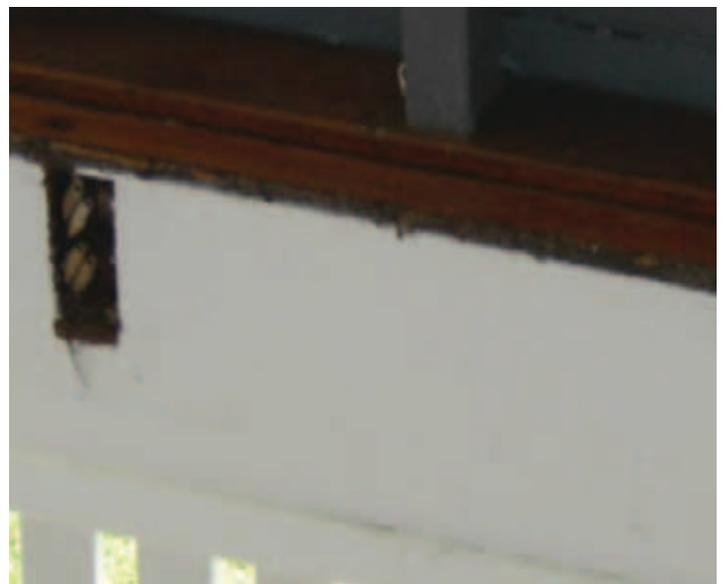
Mud wasp nests in the bearer housing is evidence that a sizeable gap existed where the floor joist cog was not fully engaged into the bearer

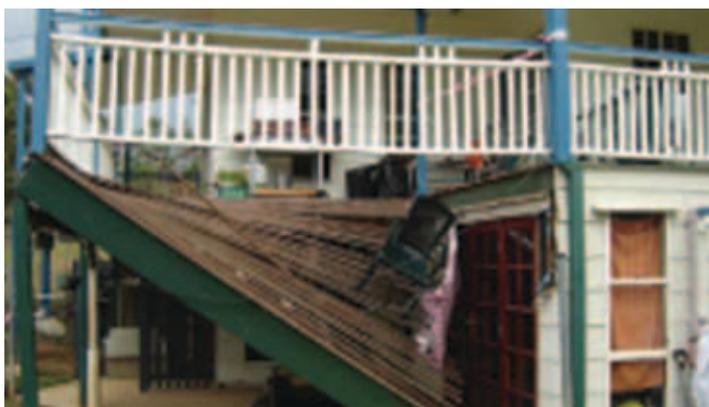
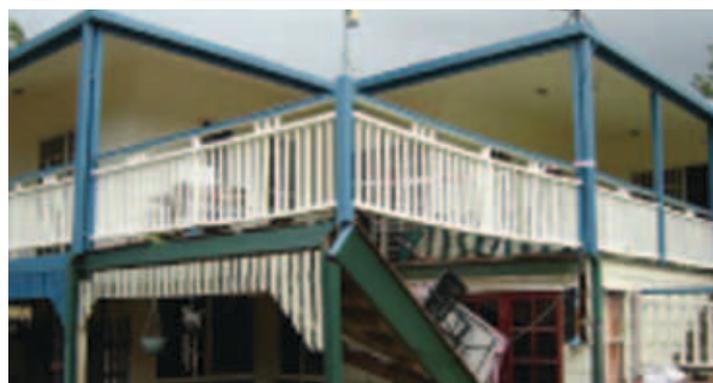
**Cause of collapse** - It appears that the south-west corner of the deck failed initially where the deck bearer was attached to the main dwelling. It was further found that the deck bearer that failed penetrated the external cladding boards and relied upon support by multiple pine corner wall studs in the wall cavity. The pine wall studs supporting the bearer were found to be totally rotted out due to the ingress of water into the wall frame.

When a substantial load was applied to the deck in the direct vicinity of the south-west corner over the bearer being supported by rotted wall studs, the inadequate support allowed the bearer to rotate downwards and the collapse occurred.

Collapsed corner of the deck is clearly visible in these photographs

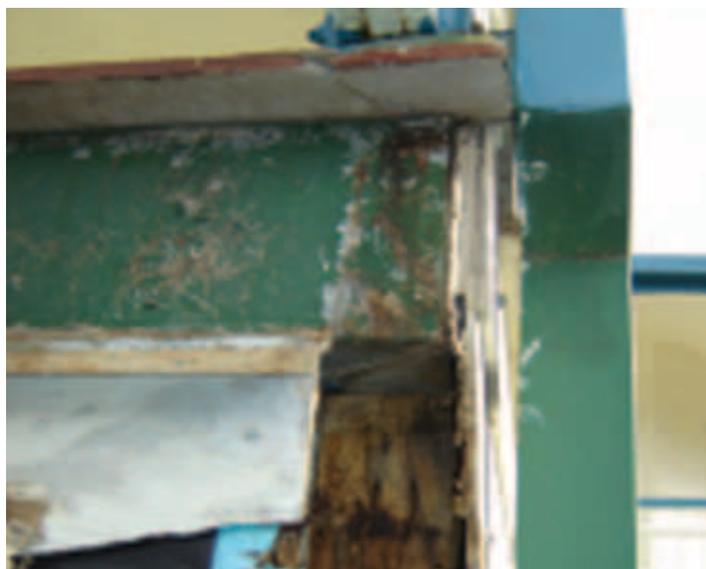
Support point for the bearer

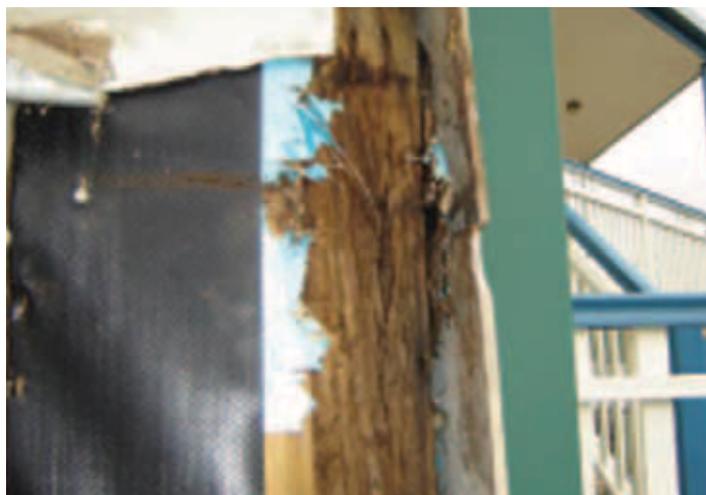
Rotted wall studs below the bearer support joint

Shrinkage/breakdown of the sealant over many years and some shrinkage of timber elements would have occurred, allowing water ingress and causing the decay to the non-durable pine studs in the enclosed wall.

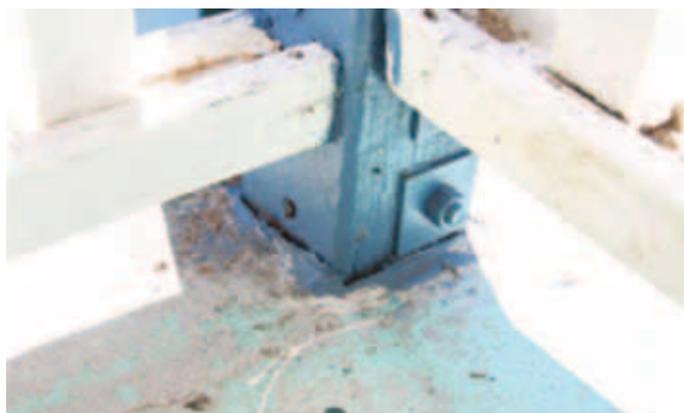
The ingress of water may have occurred where the bearer itself penetrated the wall cladding and also around the base of a timber veranda post of the main dwelling which was located directly above the location of the bearer. These points of water ingress relied solely upon sealant to prevent penetration of water.

Gaps around base of veranda post allow water ingress into wall cavity

- All structural framing members and their connections and support points below the floor level of structures such as decks, balconies and patios should be unenclosed and not sheeted to allow full visual inspection of those critical elements.
- When structural framing members and their connections and support points are enclosed and not visible for inspection, all framing and connections should be sufficiently durable to accommodate periodic wetting and drying. Alternatively, a method of inspecting the sub-structure to the deck and any building framing to which deck members are connected should be provided.
- No attachments to a dwelling such as patios, decks, balconies or the like should allow structural framing members to penetrate the external fabric of the main building unless the penetrations are flashed and sealed using permanent durable materials to prevent moisture entry.
