Technical Guide

Guide to Assessment and Repair of Flood Damaged Timber and Timber Framed Houses

(Revised Feb 2022)

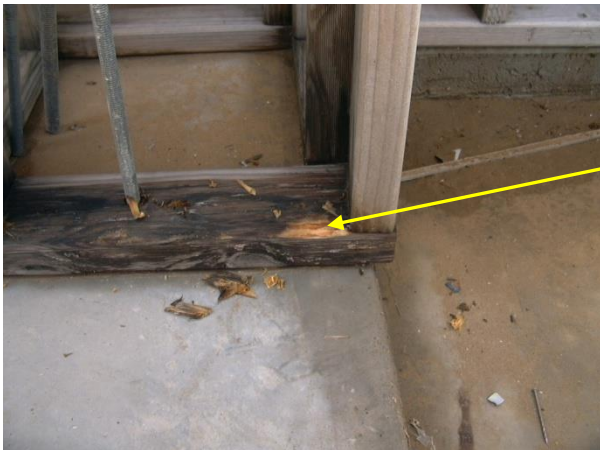
Although heavily discoloured with surface mould and blue stain, the pine timber is still sound as shown by scraping back the surface layer

If timber or wood based products remain damp or wet for prolonged periods and air (oxygen) is available, mould (dark staining) and eventually decay can occur, particularly in low durability timber such as untreated pine. Significant degradation or decay of timber is usually preceded by evidence of surface discoloration by moulds or stains, but if these are easily scraped off with a knife and the timber is sound underneath, it is not of concern. Degradation or decay in timber will be indicated if the wood has become soft and spongy or is easily penetrated with a knife or screwdriver.

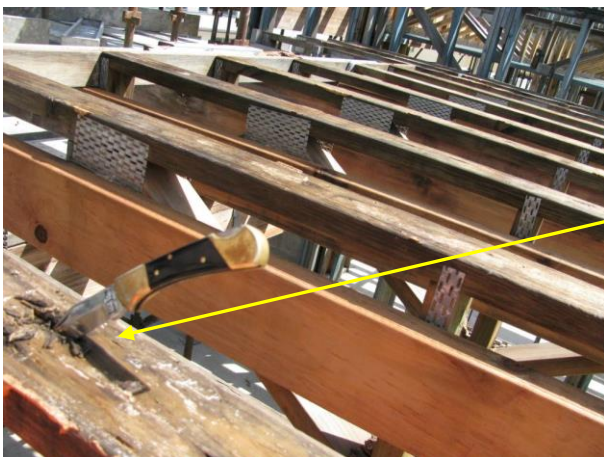
Decayed timber is soft and spongy and can easily be penetrated with a knife or screwdriver
